**Lightweight Shock and Type I Vibration Test Report
on
UPS Model No. PS3200RM
for
Powerstar Inc.
Gaithersburg, MD**

NU LABORATORIES

25 February 2014

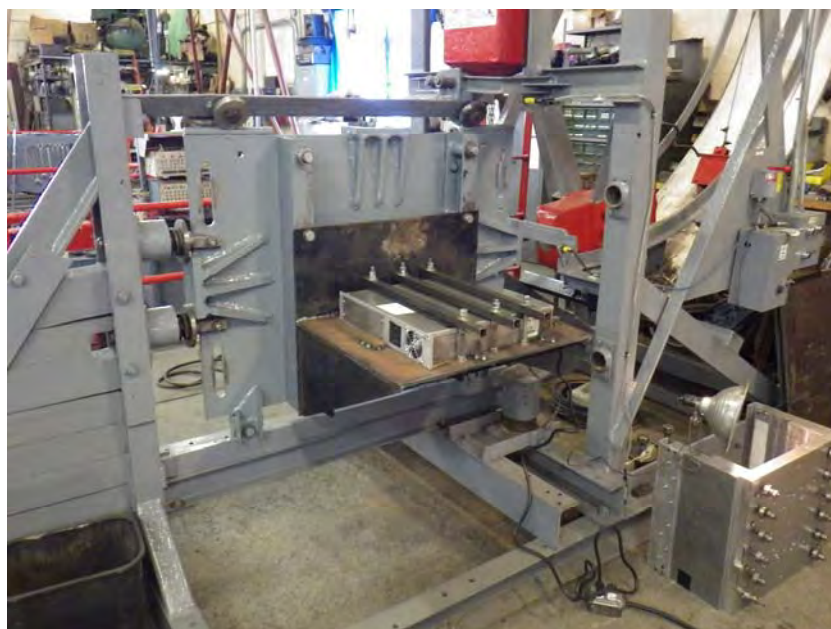
**Shock Test Setup, Front-to-Back Axis
Figure 1**

Fixture 4C, Platform 3 of MIL-S-901D was attached to the lightweight shock machine using six (6) 3/4"-10 Grade 5 bolts, nuts, and washers torqued to 260 ft-lbs. A gasket was placed on the deck of Fixture 4C, Platform 3 of MIL-S-901D. The UPS was placed on the gasket, oriented in the first major axis of test. The UPS was then clamped to Fixture 4C, Platform 3 of MIL-S-901D using three (3) clamps composed of three (3) 1-inch square clamping bars and six (6) 1/2"-13 Grade 5 threaded rods, eighteen (18) washers, and eighteen (18) nuts. Strips of rubber were placed atop the UPS at the three (3) clamping bar locations. Blocking was welded to Fixture 4C, Platform 3 of MIL-S-901D around the UPS to limit lateral movement. The total weight on the anvil table was 346 pounds. Refer to Table 1 for a breakdown of the test weights.

The UPS was supplied with 120 VAC, 1-phase, 60 Hz and energized. A light was used as a load to determine if the UPS was functional. The Powerstar representative placed the UPS in the operational condition and directed that shock testing commence. Refer to Figures 1 and 5 for photographs of the shock test setup.

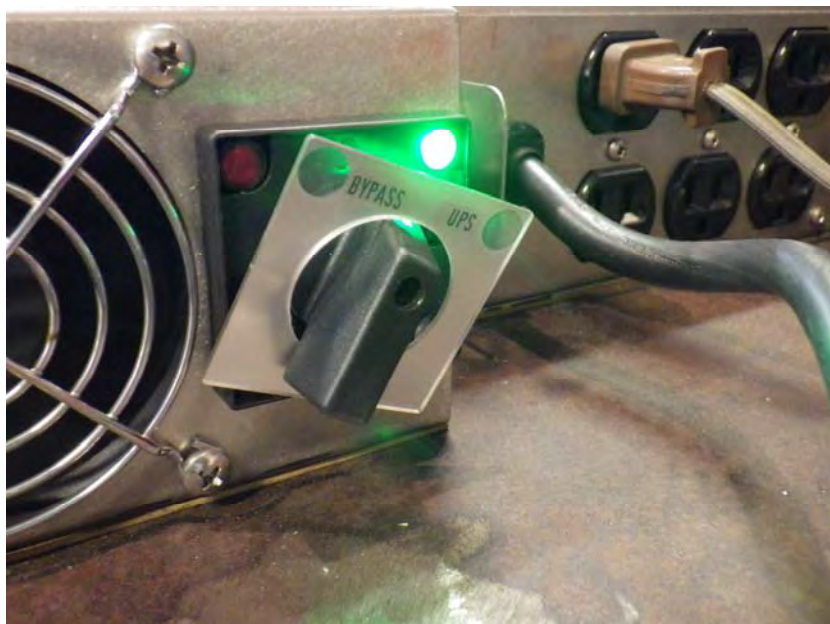
Post-Blow #1, Detached Bypass Cover
Figure 2

12.5.2 Observations: A post-blow visual inspection revealed that the bypass cover had become detached but was still located near the switch. Refer to Figure 2 for a photograph. No additional obvious physical damage or discrepancies were noted.

12.5.3 Action: The clamp hardware was retightened. Testing was continued.

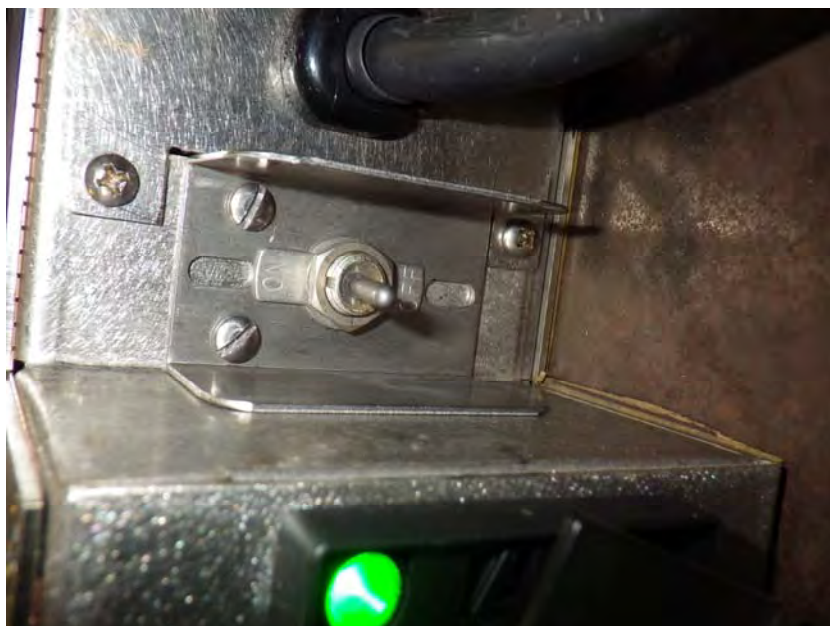
Post-Blow #3, Breaker Moved Back into Position
Figure 3

12.7.2 Observations: A post-blow visual inspection revealed that the UPS had switched to battery mode and the 120 g breaker had moved down. The Powerstar representative pulled the breaker back up; refer to Figure 3. The UPS reverted from battery mode to AC mode. It was noted that the UPS maintained the load at all times. It was further noted that the battery cover was bent; refer to Figure 4. No additional obvious physical damage or discrepancies were noted. The UPS was noted to operate without discrepancy.

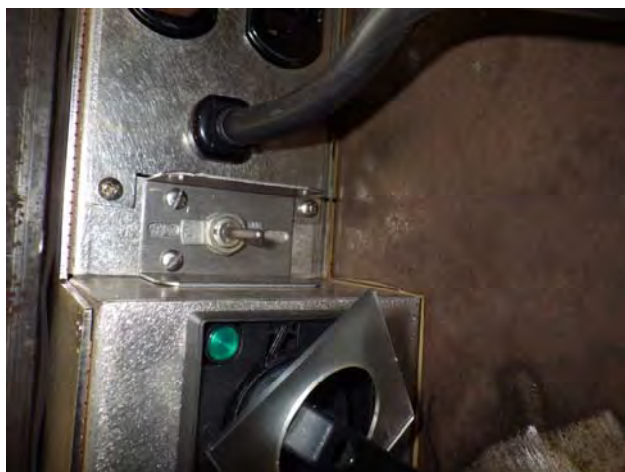
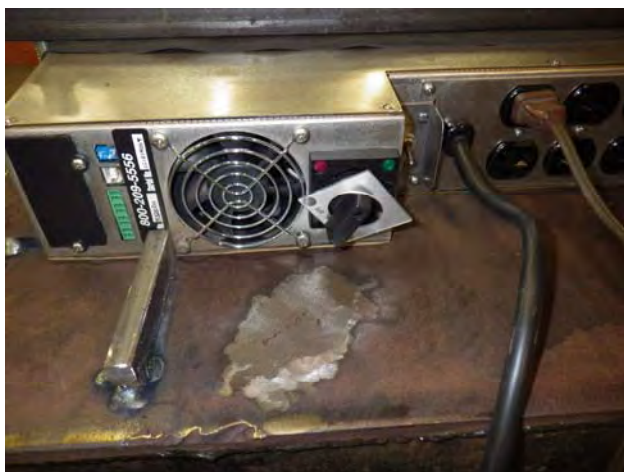
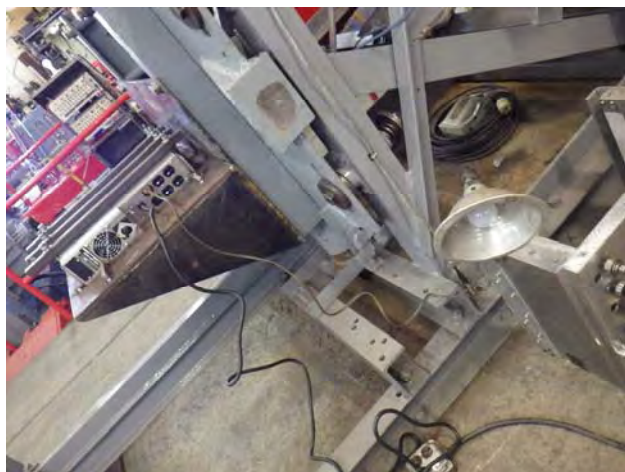
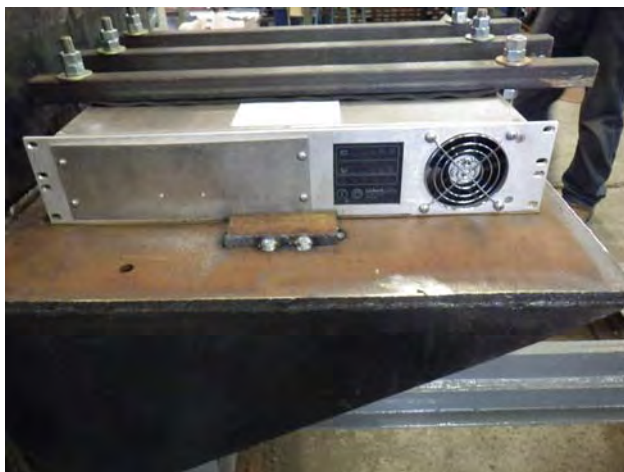
**Post-Blow #9, Bent Battery Cover
Figure 6**

12.13.2 Observations: A post-blow visual inspection revealed that the breaker previously noted to move after Blow #3 had again moved down. The UPS did not switch to battery mode. It was further noted that the UPS became de-energized. Refer to Figure 6 for photographs. The Powerstar representative noted that the UPS had failed.

Breaker Switch in the Down Position

Back of UPS; All Lights De-illuminated

Load Light De-illuminated

Front of UPS; All Lights De-illuminated

12.13.3 Action: The Powerstar representative restarted the UPS, which was noted to then become energized. The representative requested that Blow #9 be repeated.

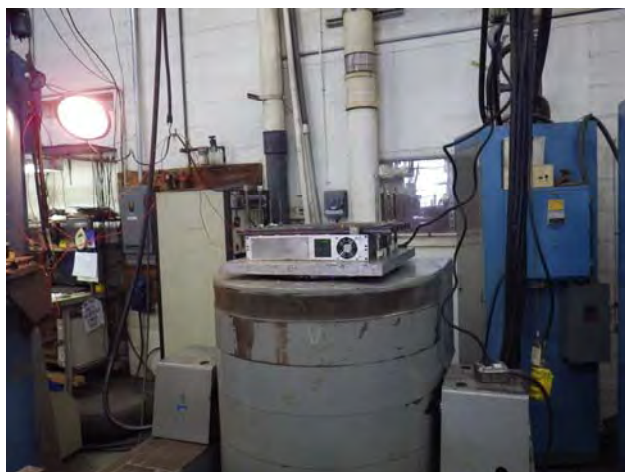
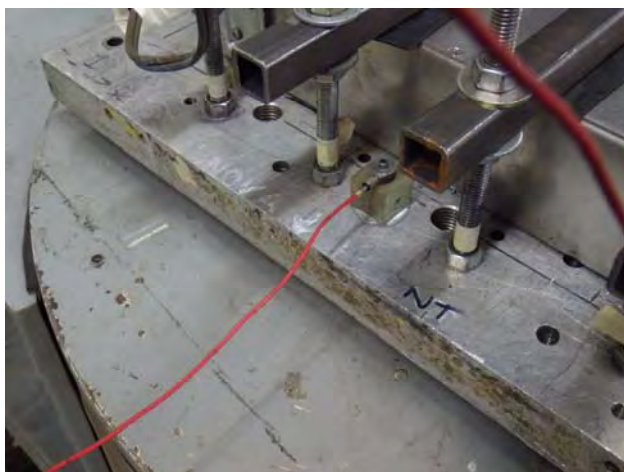
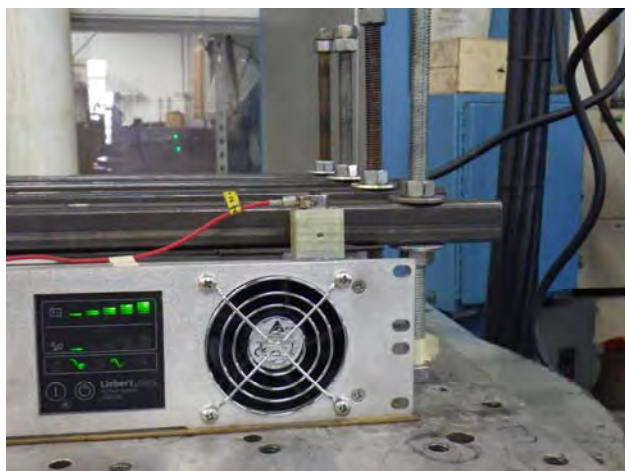
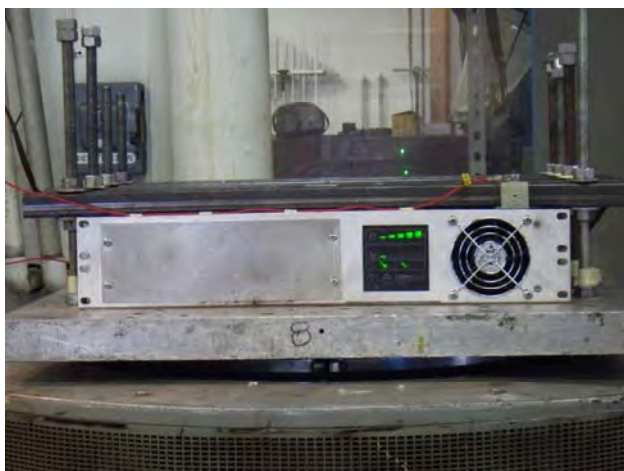
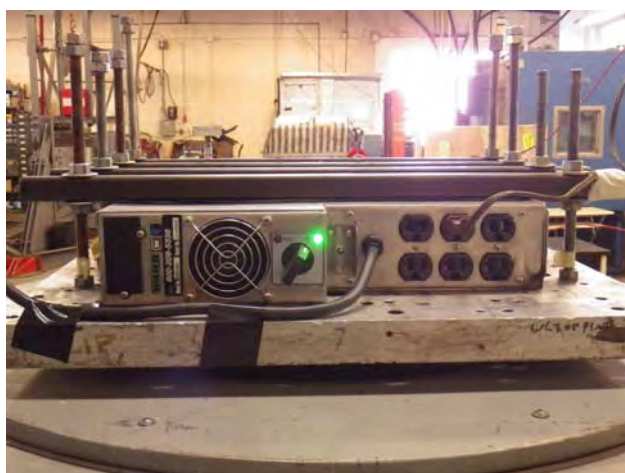
**Vibration Test Setup, Vertical Axis
Figure 9**

Upon completion of shock testing, the UPS was removed from Fixture 4C, Platform 3 of MIL-S-901D and clamped to a test plate on the vibration machine using four (4) clamps, oriented in the first major axis of test. The UPS was energized with 120 VAC, 1-phase, 60 Hz and placed in the operational condition; no discrepancies were noted. The test load light was attached to the UPS; no discrepancies were noted.

One (1) input accelerometer was attached to the test plate, oriented in the direction of vibration, to record the vibration input and one (1) response accelerometer was attached to the forward right corner on top of the UPS to aid in the detection of response prominences. Refer to Table 2 for the accelerometer locations. Refer to Figures 9 through 11 for photographs of the vibration test setups.

Vertical Axis, Load Light Illuminated

Channel 1 (Input) Accelerometer, Test Plate

Channel 2 Accelerometer, Right Corner, Top of UPS
